REHEATER REBUILD FOR ENHANCED RELIABILITY & REDUCED MAINTENANCE

September 14, 2010

Nebraska's Largest Electric Utility
Sutherland, NE
Commercial Operation
Electrical Generation
Main Steam Flow lbs./hr.
RH Design Pressure
SH/RH Steam Temp.
Type of Firing
Boiler OEM Manufacturer

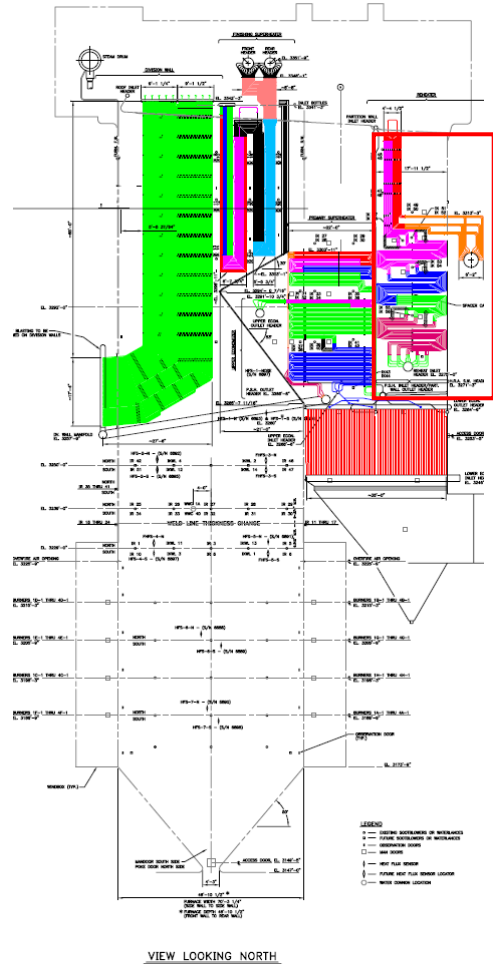
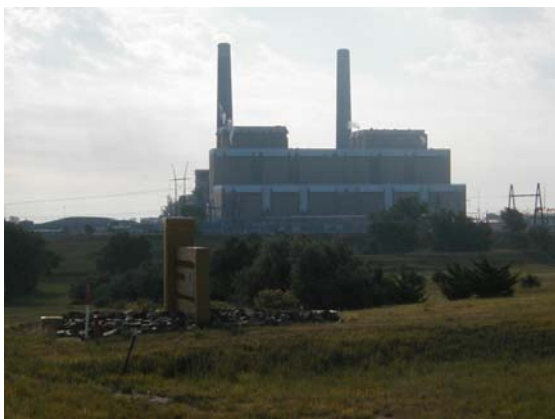
VIEW LOOKING NORTH

The surface arrangement in this particular design is parallel gas flow design (horizontal primary SH and a horizontal reheater) with the steam essentially counter-flow to the gas stream. Each element is end supported with a span between the supporting tube centerlines wall of 18'-0".
