REHEATER REBUILD FOR ENHANCED RELIABILITY & REDUCED MAINTENANCE

September 14, 2010

Nebraska's Largest Electric Utility
Sutherland, NE
Commercial Operation
Electrical Generation
Main Steam Flow lbs./hr.
RH Design Pressure
SH/RH Steam Temp.
Type of Firing
Boiler OEM Manufacturer

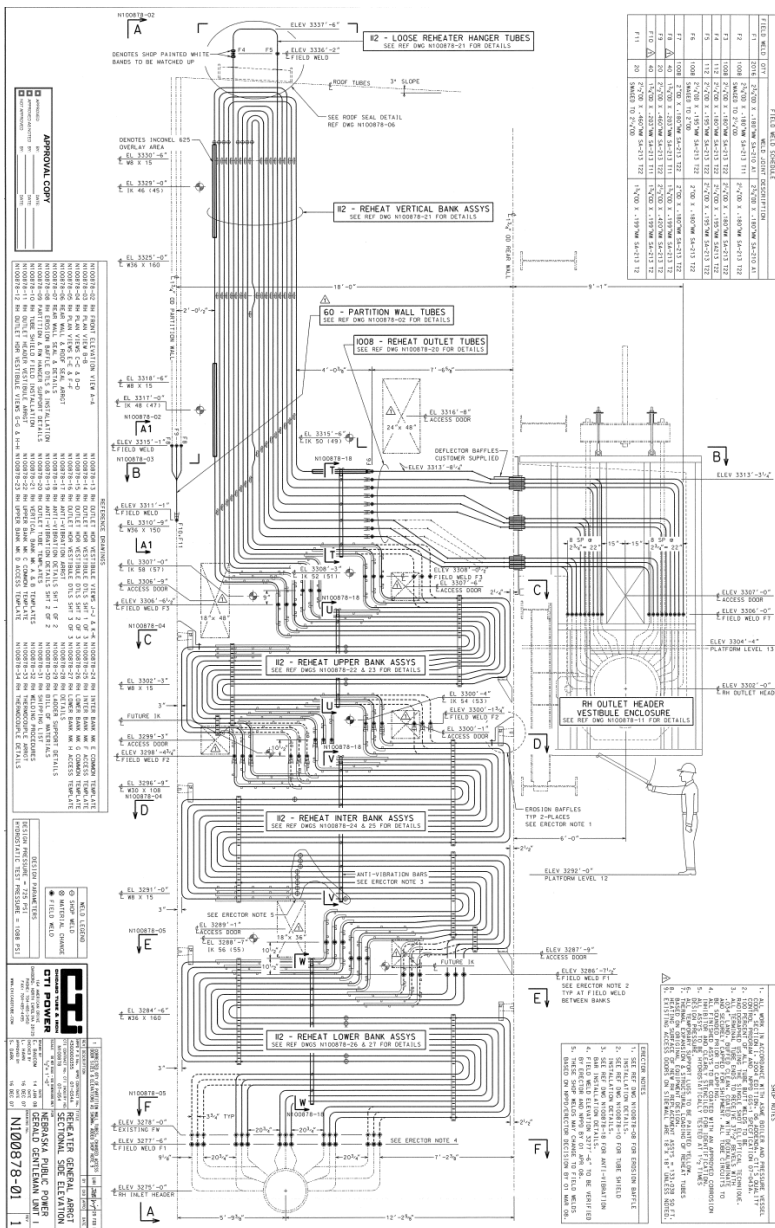
Working closely with this utility's project personnel, we selectively located 0.070 thick Inconel 625 spiral weld overlay adjacent to sootblower wash areas in the leading edge tube of the inverted vertical pendant elements, as well as the top horizontal tube at the swage transition to the horizontal outlet rows.
